# ICC-ES Recognizes Innovative Solutions to Industry's Stair Rail Safety Concerns

## How Not to Build a Deck

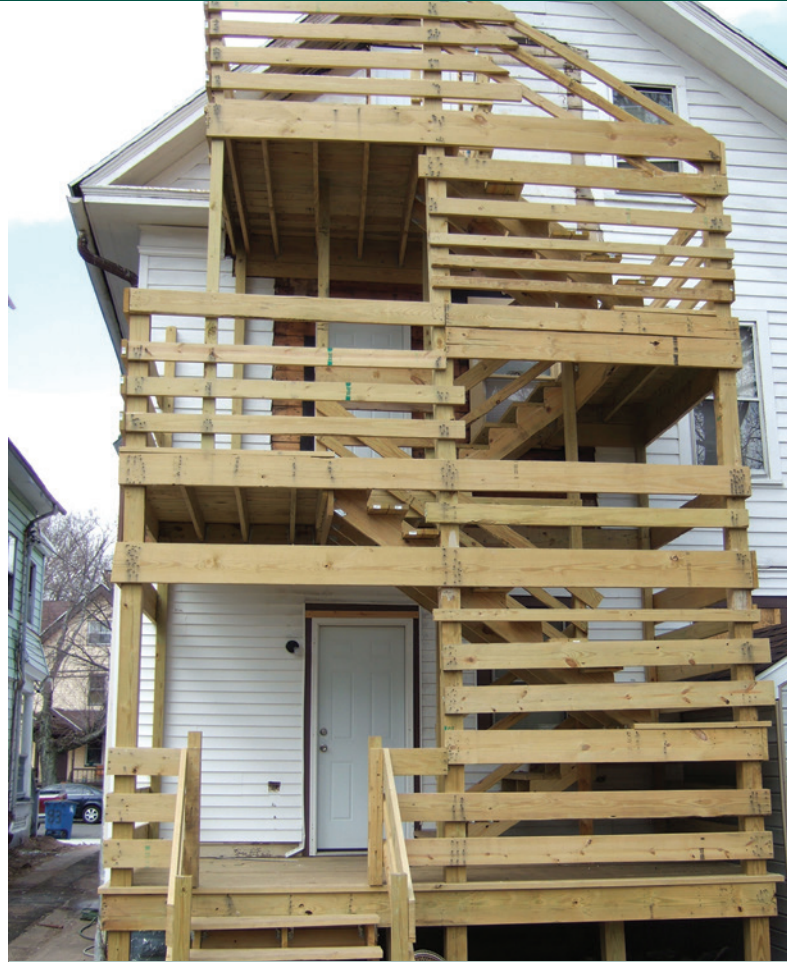
*Photo Credit: James Eggert, Building Inspector, City of New Haven, CT*

Unfortunately, this is not always the case for guardrails, specifically when they are attached to wood stairs. Guardrails are normally secured to rail post supports, which in turn are attached to a stringer. Some within the building industry have expressed concern that the standard installation methods used for rail post attachment fall short of meeting the lateral load capacity required by code. Products, such as the bracket evaluated in ESR-2295, help ensure that current and future construction meets this requirement.

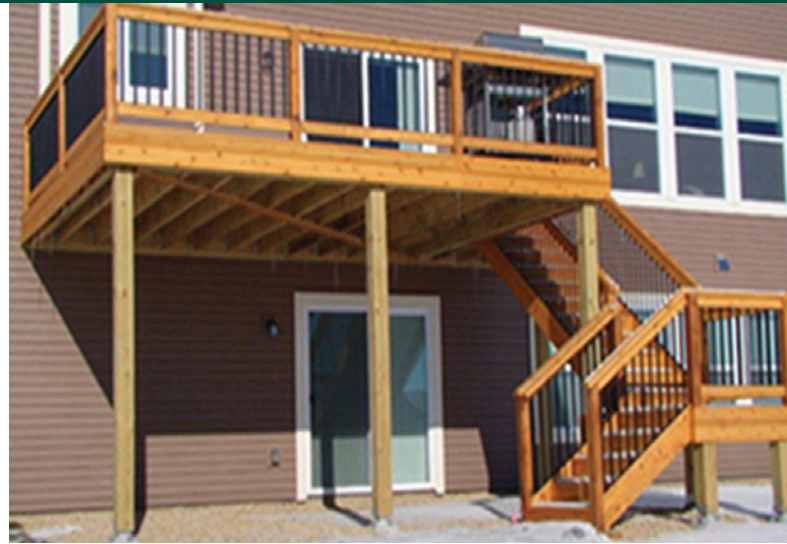
An IAS accredited testing facility was engaged by EZ Stairs® to test the load capacity of this traditional construction practice. A stair was constructed, with three 2x12 cut stringers and two 2x6 members for each tread, using dry, #2 Douglas Fir. Three 48-inch-long posts were attached using two 3/8-inch galvanized bolts. The top bolt was attached through the triangular cut portion of the stringer (normal practice) and the bottom bolt passed through the uncut portion of the stringer. A 3/8-inch eye bolt was attached 36 inches above the nose of the tread as the load point. The load was applied to each post and measured using a dynamometer. In each case, the bolt pulled through the cut, triangular rise/tread tip of the stringer at a load of just 20 pounds. As the load was increased to 50 pounds, severe longitudinal cracks were seen along the length of the stringers, breaking all triangular tips and resulting in complete failure of both the stringer and the rail post support.

“The results were surprising,” said Truckner. All three tests consistently showed significant structural failure occurring at minimal loads and several reasons for the early failure were identified. The post acted as a lever against the stringer, magnifying the load on each bolt. A 20-pound pull at the guardrail level resulted in a 120-pound force at the base of the post and caused the top bolt to pull through the stringer. Once the top bolt had broken through, the bottom bolt was left to resist the entire load. The mechanical advantage was further amplified by the lower position of the bottom bolt, and the final 50-pound pull on the guard rail became a 1,200-pound force at the base. This was enough to twist the stringer and cause it to crack longitudinally. “It must be pointed out that these tests
